**Flood Control Project Maintenance  
Levee Inspections****LMA District Cover Sheet****Spring 2016 Levee Inspection Results****Reclamation District No. 0501 Ryer Island**

**Spring 2016 Levee Inspection Results**

**Reclamation District No. 0501 Ryer Island**

Waterway			Bank	Unit Miles
Unit No. 01 Steamboat Slough			Right	6.71
	Spring (March - May)	Summer (June - August)	(September - November) Fall	Winter (December - February)
Unit Maintenance Rating (Fall Only)				
Date of Inspection	3/24/2016 - 3/24/2016			
DWR Inspector	Herman Phillips			
Accompanied By	Nicolas Zepeda RD 501

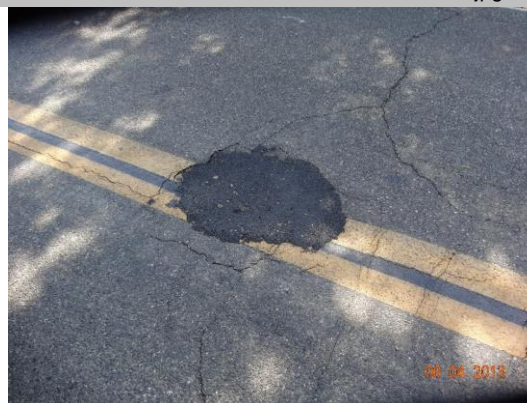
Photo 2 of 2 : UCIP\_SP\_2016\_44766\_58922.jpg

FS\_ID:44766  
DS\_ID:21030  
EP\_NO: 4581  
Repair Type: Urgent  
Crossing Status: Found  
UCIP Comments: Damage present on levee crown--unable to confirm if damage due to leak in pipe. Signs of repair work on crown, however, no permit found to document recent damage to levee or repair work. New PVC pipe has been sleeved through the existing 6-inch pipe. Unable to determine if crossing is still in use, if not, crossings needs to be removed according to CVFPB Title 23 requirements.  
FIELD\_STRUCT\_DESC: 6-inch steel pipe through the levee, 2.5 feet below the crown. 2-inch steel electrical conduit through levee. Cutoff wall around pipe at center of levee. Pump and gate valve in pump structure on waterward slope. Service pole on landward slope. Pipe exposed on both slopes. (Permit No. 4581-1964)  
FS Date: 4/21/2015 1:59:00 PM

Subsidence and patch work repair on crown.

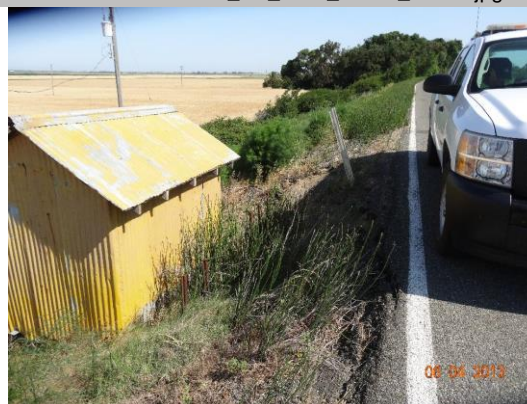
Photo 2 of 2 : UCIP\_SP\_2016\_32524\_58927.jpg

LM Start	0.39	Rating **	M	Issue No.	980
LM End	0.39	Issue Type +	En	Location *	LS
Category	Supplemental			GPS Latitude/Longitude	
				Start	End
Item	DWR UCIP Field Study			38.249197 °	38.249197 °
				-121.603061 °	-121.603061 °
DWR ID					
Comment Code					
Inspector Comment					
FS_ID:32524 DS_ID:21031 EP_NO: N/A Repair Type: Non-Urgent Crossing Status: Found UCIP Comments: Dense vegetation limits the inspector's visibility to identify signs of leaks through the slope. Recommend removing vegetation along pipe alignment for reinspection. Need to contact the owner to clear slope along crossing. FIELD_STRUCT_DESC: 20-inch and 2.5-inch pipes through the levee, both 7.8 feet below the crown. Pump in pump house on landward slope. Pipe exposed along waterward slope. (USACE-1959). This entry matches the Drainage or Irrigation Structure referenced in O&M manual (HLM 0.40). FS Date: 6/4/2013

Overview of landside. Pump house and power pole visible on landward side.

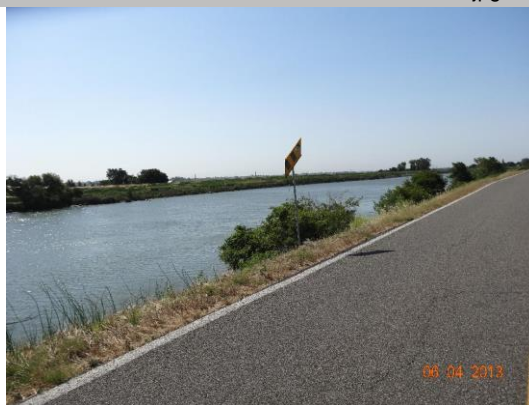
Photo 1 of 2 : UCIP\_SP\_2016\_41409\_58931.jpg

LM Start	0.44	Rating **	M	Issue No.	987
LM End	0.44	Issue Type +	En	Location *	LS
Category	Supplemental			GPS Latitude/Longitude	
				Start	End
Item	DWR UCIP Field Study			38.248519 °	38.248519 °
				-121.602972 °	-121.602972 °
DWR ID					
Comment Code					
Inspector Comment					
FS_ID:41409 DS_ID:21032 EP_NO: N/A Repair Type: Non-Urgent Crossing Status: Found UCIP Comments: Need to contact owner and ask for emergency contact information and permit number. 8/21/13 Contacted Gas Control Division under the emergency contact No. 1-877-723-3344. Message has been forward to Brian Habersack at 916-859-4700, email: bhabersack@gasbiz.com. FIELD_STRUCT_DESC: 6-inch Steel Gas line through the levee 60-feet below the crown. Markers on both shoulders (Permit No. 17033, 2014). FS Date: 6/4/2013

Overview of waterside at crossing. Marker on shoulder.

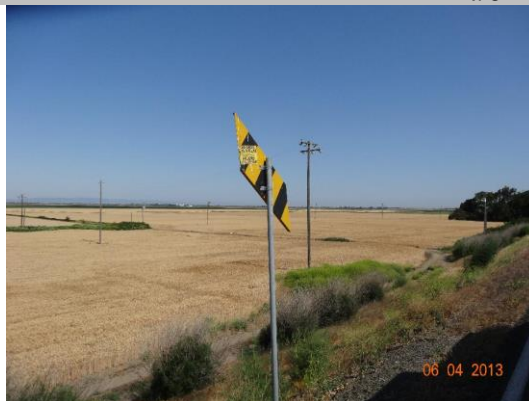
Photo 2 of 2 : UCIP\_SP\_2016\_41409\_58930.jpg

LM Start	0.44	Rating **	M	Issue No.	987 (cont)	
LM End	0.44	Issue Type +	En	Location *	LS	
Category	Supplemental			GPS Latitude/Longitude		
				Start		End
Item	DWR UCIP Field Study			38.248519 °		38.248519 °
				-121.602972 °		-121.602972 °
DWR ID						
Comment Code						
Inspector Comment						
FS_ID:41409						
DS_ID:21032						
EP_NO: N/A						
Repair Type: Non-Urgent						
Crossing Status: Found						
UCIP Comments: Need to contact owner and ask for emergency						
contact infomation and permit number. 8/21/13 Contacted Gas						
Control Division under the emergency contact No. 1-877-723-3344.						
Message has been forward to Brian Habersack at 916-859-4700, email:						
bhabersack@gasbiz.com.						
FIELD_STRUCT_DESC: 6-inch Steel Gas line through the levee 60-						
feet below the crown. Markers on both shoulders (Permit No. 17033,						
2014).						
FS Date: 6/4/2013

Overview of landside at crossing. Marker on shoulder.

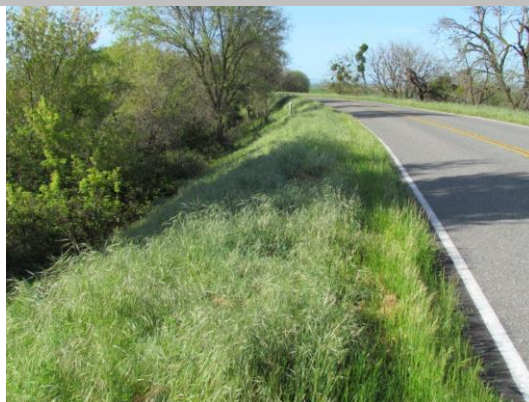
Photo 1 of 1 : SP\_2016\_RD0501\_169\_44\_20160329\_00058.jpg

LM Start	0.53	Rating **	U	Issue No.	44
LM End	5.06	Issue Type +	Ma	Location *	WS
Category	Earthen Levee			GPS Latitude/Longitude	
				Start	End
Item	Vegetation			38.247188 °	38.195012 °
				-121.602900 °	-121.631900 °
DWR ID	DWR_RD0501_01_s_2016_44				
Comment Code					
V1 : Control annual grass and weeds on the levee slopes and easements.					
Inspector Comment					
Tall unwanted weeds on the waterside levee section.

Looking downstream from levee mile 0.04 landside shoulder and slope.

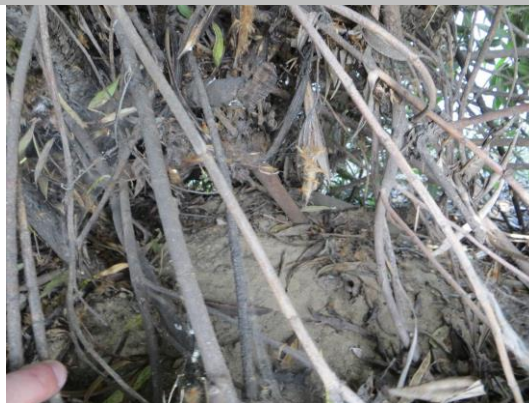
Photo 1 of 2 : UCIP\_SP\_2016\_44643\_73842.jpg

LM Start	0.70	Rating **	M	Issue No.	988
LM End	0.70	Issue Type +	En	Location *	LS
Category	Supplemental			GPS Latitude/Longitude	
				Start	End
Item	DWR UCIP Field Study			38.244726 °	38.244726 °
				-121.602900 °	-121.602900 °
DWR ID					
Comment Code					
Inspector Comment					
FS_ID:44643 DS_ID:21089 EP_NO: 2683 Repair Type: Non-Urgent Crossing Status: Indicator Found UCIP Comments: Appears abandoned and if so should be done so properly. FIELD_STRUCT_DESC: 2-inch steel water pipe and 1-inch steel electrical conduit through the levee, both 3.0 feet below the crown. Portion of pipe visible under oleanders on LS shoulder may be part of this crossing. No evidence remains on WS slope. (Permit No. 2683-1959, J. Gosner) FS Date: 4/21/2015

Pipes visible under oleander on LS shoulder.

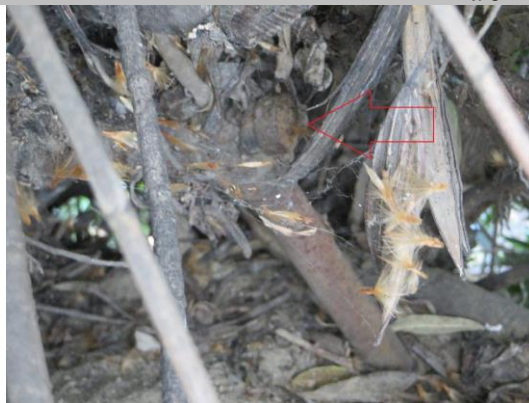
Photo 2 of 2 : UCIP\_SP\_2016\_44643\_73841.jpg

LM Start	0.70	Rating **	M	Issue No.	988 (cont)	
LM End	0.70	Issue Type +	En	Location *	LS	
Category	Supplemental			GPS Latitude/Longitude		
				Start		End
Item	DWR UCIP Field Study			38.244726 °		38.244726 °
				-121.602900 °		-121.602900 °
DWR ID						
Comment Code						
Inspector Comment						
FS_ID:44643 DS_ID:21089 EP_NO: 2683 Repair Type: Non-Urgent Crossing Status: Indicator Found UCIP Comments: Appears abandoned and if so should be done so properly. FIELD_STRUCT_DESC: 2-inch steel water pipe and 1-inch steel electrical conduit through the levee, both 3.0 feet below the crown. Portion of pipe visible under oleanders on LS shoulder may be part of this crossing. No evidence remains on WS slope. (Permit No. 2683-1959, J. Gosner) FS Date: 4/21/2015

Pipes visible under oleander on LS shoulder.

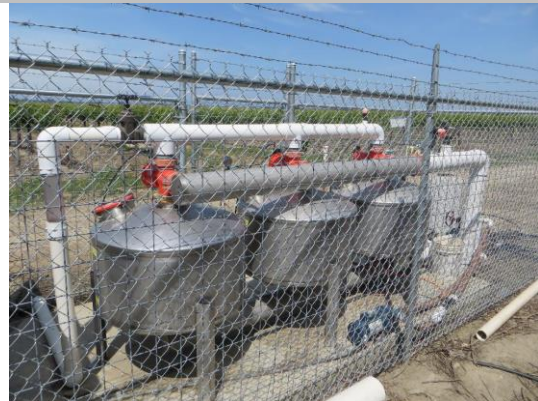
Photo 1 of 2 : UCIP\_SP\_2016\_47516\_73857.jpg

Comment Code					
Inspector Comment					
FS_ID:47516 DS_ID:21086 EP_NO: 13233 Repair Type: Non-Urgent Crossing Status: Found UCIP Comments: Annular space between pipes not grouted. FPIIB Inspector Herman Phillips will contact owner regarding lack of permit for sand filters. Steel plate partially covers openings between pipes. FIELD_STRUCT_DESC: 14-inch steel pipe through the levee, 2.5-feet below the crown. Cutoff wall around pipe at center of levee. Pump and check valve in pump house on waterward slope. Service pole on landward slope. (Permit No. 13233-1982) 8-inch steel irrigation pipe sleeved through 14-inch (under Permit No. 11813-1, 2013). A 1.5 and a 2.5-inch electrical conduit at same location. Siphon breaker on both shoulders. FS Date: 4/21/2015

Sand filter plant on LS toe.

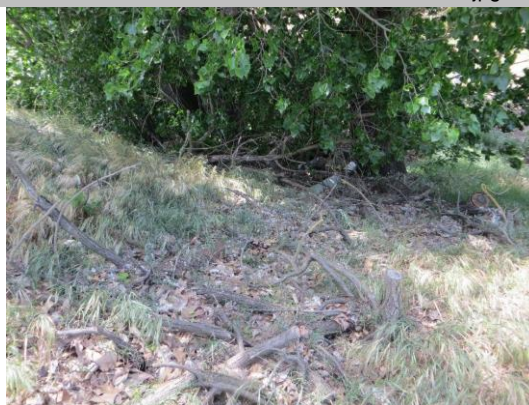
Photo 1 of 2 : UCIP\_SP\_2016\_44683\_73882.jpg

LM Start	2.34	Rating **	M	Issue No.	990
LM End	2.34	Issue Type +	En	Location *	LS
Category	Supplemental			GPS Latitude/Longitude	
				Start	End
Item	DWR UCIP Field Study			38.221277 °	38.221277 °
				-121.603505 °	-121.603505 °
DWR ID					
Comment Code					
Inspector Comment					
FS_ID:44683					
DS_ID:21021					
EP_NO: N/A					
Repair Type: Non-Urgent					
Crossing Status: Found					
UCIP Comments: Appears abandoned and if so should be done so properly. Discarded pipe on WS slope should be removed.					
FIELD_STRUCT_DESC: 10-inch steel irrigation pipe through the levee, 2.5-feet below the crown. Pump and gate valve in pump house on waterward slope. a 4'X4' concrete distribution box, power pole, and meter on LS toe (USACE-1959). This entry matches the Drainage or Irrigation Structure referenced in O&M manual (HLM 2.50).					
FS Date: 4/21/2015

Pipe visible on LS slope.

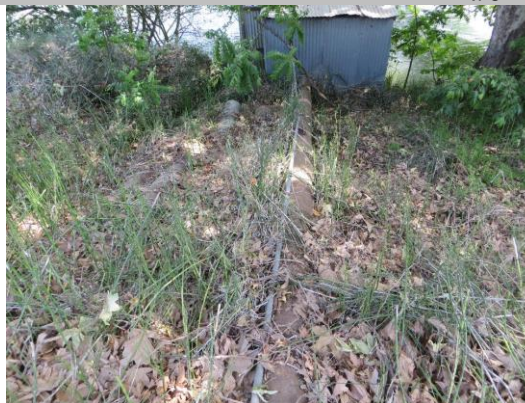
Photo 2 of 2 : UCIP\_SP\_2016\_44683\_73881.jpg

LM Start	2.34	Rating **	M	Issue No.	990 (cont)	
LM End	2.34	Issue Type +	En	Location *	LS	
Category	Supplemental			GPS Latitude/Longitude		
				Start		End
Item	DWR UCIP Field Study			38.221277 °		38.221277 °
				-121.603505 °		-121.603505 °
DWR ID						
Comment Code						
Inspector Comment						
FS_ID:44683 DS_ID:21021 EP_NO: N/A Repair Type: Non-Urgent Crossing Status: Found UCIP Comments: Appears abandoned and if so should be done so properly. Discarded pipe on WS slope should be removed. FIELD_STRUCT_DESC: 10-inch steel irrigation pipe through the levee, 2.5-feet below the crown. Pump and gate valve in pump house on waterward slope. a 4'X4' concrete distribution box, power pole, and meter on LS toe (USACE-1959). This entry matches the Drainage or Irrigation Structure referenced in O&M manual (HLM 2.50). FS Date: 4/21/2015

Pipe and pumphouse on WS slope.

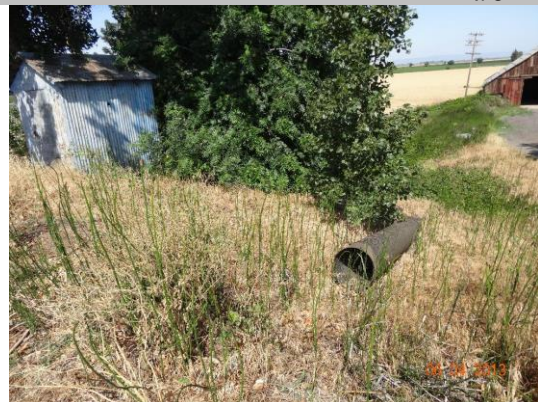
Photo 2 of 2 : UCIP\_SP\_2016\_32526\_58935.jpg

FS\_ID:32526  
DS\_ID:21022  
EP\_NO: 2742  
Repair Type: Non-Urgent  
Crossing Status: Found  
UCIP Comments: Dense vegetation limits the inspector's visibility to identify signs of pipe failure (leaks) through the levee slopes. Recommend removing vegetation along pipe alignment to conduct proper inspection of structure and appurtenances. Additional notes: pump was running during inspection, 16-inch pipe debris section located on landward side, view of standpipe and support structure on waterward side does not match structure description--need to determine if crossing has been altered.  
FIELD\_STRUCT\_DESC: 16-inch drainpipe through the levee, 3.6 feet below the crown. Cutoff walls around pipe at center of levee. Siphon breaker on apex of pipe at landward shoulder. Pump house on landward shoulder. Pipe discharges into 48-inch pipe with screw gate on landward side. (Permit No. 2742-1959). Repairs made to pipe and a portion replaced, from landward shoulder to discharge end on waterward side, under Permit No. 15380 (1999). Rock revetment placed on waterward slope. Revegetation in progress on waterside.

Pump house on landward slope. An abandoned pipe section on landward slope.

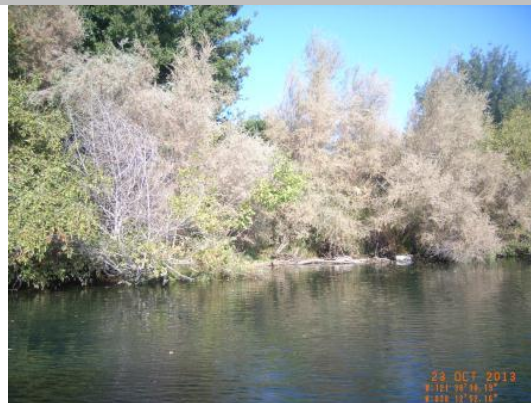
Photo 1 of 1 : SP\_2016\_RD0501\_169\_3\_20160223\_00003.jpg

LM Start	2.85	Rating **	M	Issue No.	3
LM End	2.91	Issue Type +	Ma	Location *	WS
Category	Supplemental			GPS Latitude/Longitude	
				Start	End
Item	2015 USACE Erosion Survey, DRAFT			38.214838 °	38.214075 °
				-121.608129 °	-121.608750 °
DWR ID	DWR_RD0501_01_s_2016_3				
Comment Code					
Inspector Comment					
2009 - Rock is starting to unravel, probably from a tree pop-out, hard toe. 2015: No observed changes. [2015 Site ID: STM_18-9_R]

USACE 2013 Photo #1

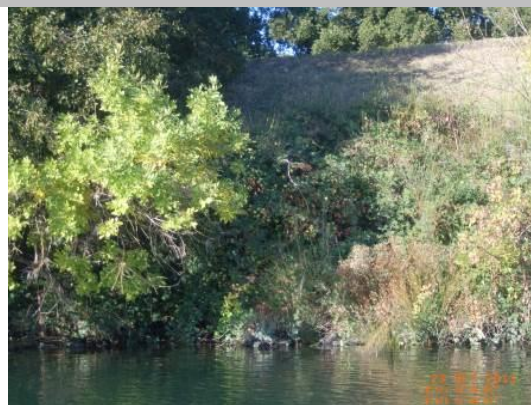
Photo 1 of 1 : SP\_2016\_RD0501\_169\_2\_20160223\_00002.jpg

LM Start	3.04	Rating **	M	Issue No.	2
LM End	3.11	Issue Type +	Ma	Location *	WS
Category	Supplemental			GPS Latitude/Longitude	
				Start	End
Item	2015 USACE Erosion Survey, DRAFT			38.212573 °	38.211596 °
				-121.609760 °	-121.609928 °
DWR ID	DWR_RD0501_01_s _ 2016_2				
Comment Code					
Inspector Comment					
2000 - Slow erosion of lower and mid-slope with rock bench at the low water line. 2015: No observed changes. [2015 Site ID: STM_18-8_R]

USACE 2013 Photo #1

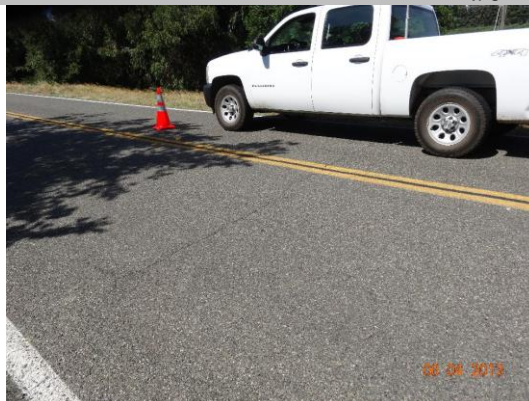
Photo 1 of 2 : UCIP\_SP\_2016\_42925\_58942.jpg

FS\_ID:42925  
DS\_ID:21026  
EP\_NO: N/A  
Repair Type: Urgent  
Crossing Status: Found  
UCIP Comments: Damage present to pipe (leak). Additional notes available: 8-inch is leaking on landward side--white sealant and rag used to seal hole, single line crack on the crown of the alignment, pipe through the levee could be bigger than 8-inch unable to confirm. Also found a 3-inch steel pipe approximately 7 feet upstream from 8-inch pipe (authorized or unauthorized?). Need to contact owner to coordinate with CVFPB.  
FIELD\_STRUCT\_DESC: 8-inch steel pipe and 1.5-inch steel electrical conduit through the levee, both 2.0 feet below the crown. Gate valve on waterward side. Cutoff wall around pipe and conduit at center of levee. Siphon breaker on apex of pipe at landside shoulder. Pump on piling structure on waterward slope installed under Permit No. 9880 (1975). Meter pole at landward toe. Pipe exposed along landward slope. Discharge filter on landward slope installed under Permit No. 9880-B (1975).

View of levee crown at crossing. Single line crack on levee crown.

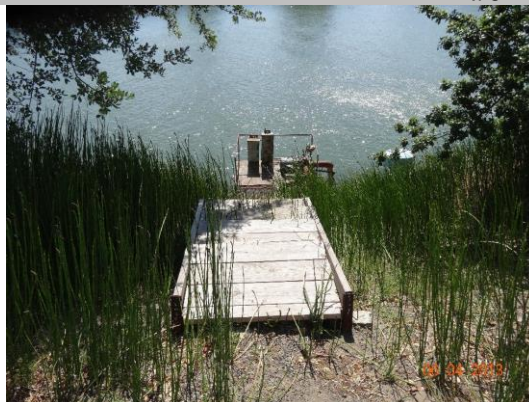
Photo 2 of 2 : UCIP\_SP\_2016\_42925\_58940.jpg

Station details--gate valve, air vent, and other appurtenances.

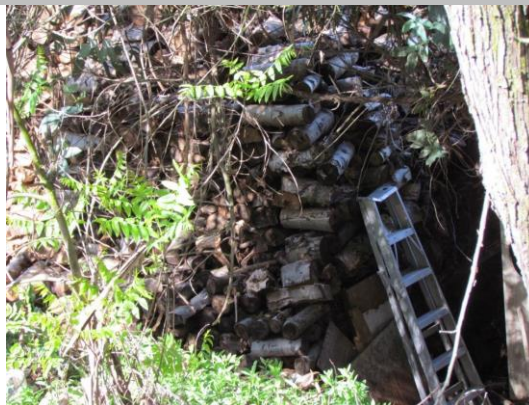
Photo 2 of 2 : SP\_2016\_RD0501\_169\_63\_20160404\_00066.jpg

Firewood stored within the landside easement.

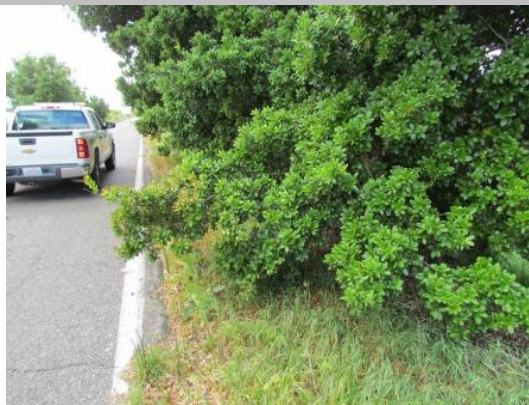
Photo 1 of 1 : SP\_2016\_RD0501\_169\_43\_20160223\_00005.jpg

Woody tree growth on levee slope and shoulder of the landside. No new photo taken.

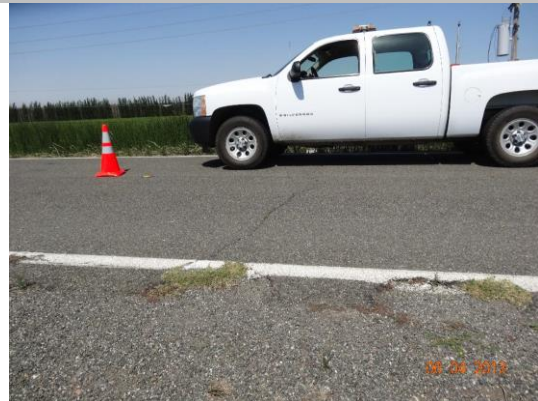
Photo 1 of 2 : UCIP\_SP\_2016\_32529\_58954.jpg

Comment Code					
Inspector Comment					
FS_ID:32529 DS_ID:21028 EP_NO: N/A Repair Type: Non-Urgent Crossing Status: Found UCIP Comments: Pipe was running during inspection. Crack on crown surface could be associated with pipe vibration during operation. Need to determine owner of crossing. Owner will need to clear vegetation along pipe alignment on landward side to prevent levee inspection along crossing. FIELD_STRUCT_DESC: 20-inch pipe through the levee, 2.2 feet below the crown. 1.5-inch electrical conduit along side 20 inch pipe. Pump on platform on waterward side. Walkway present on waterward side. Stand pipe located on landward toe. Pipe exposed along both slopes. (USACE-1959). This entry matches the Drainage or Irrigation Structure referenced in O&M manual (HLM 3.70). FS Date: 6/4/2013

Single line crack on crown.

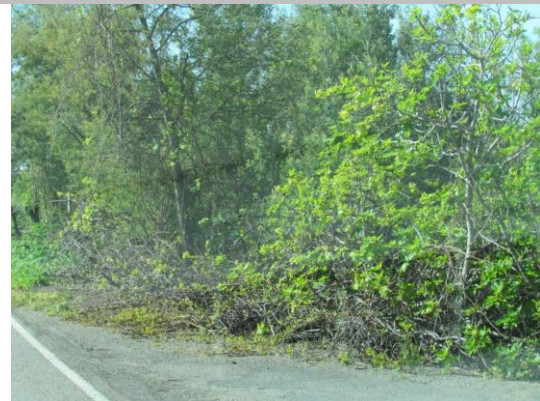
Photo 1 of 1 : SP\_2016\_RD0501\_169\_67\_20160404\_00068.jpg

Looking downstream from the landside shoulder and slope levee mile 3.73 unwanted fig trees.

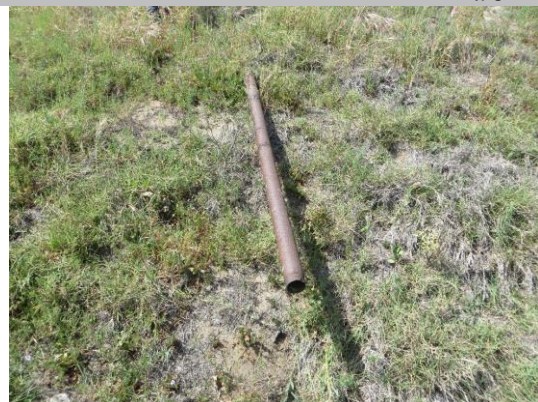
Photo 1 of 2 : UCIP\_SP\_2016\_44716\_73901.jpg

2.5-inch conduit visible on WS slope.

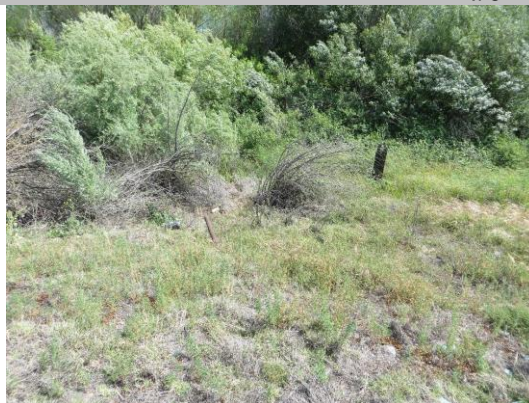
Photo 2 of 2 : UCIP\_SP\_2016\_44716\_73900.jpg

2.5-inch conduit visible on WS slope.

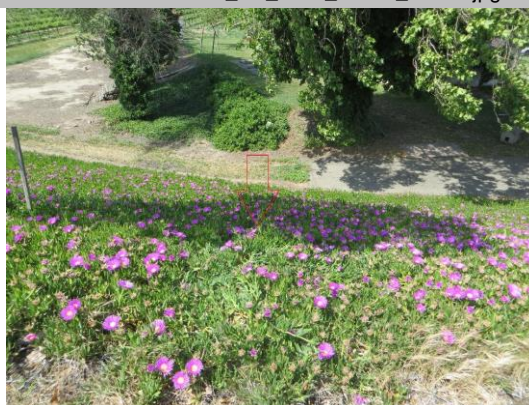
Photo 2 of 2 : UCIP\_SP\_2016\_44720\_73903.jpg

Mound at pipe visible on LS slope.

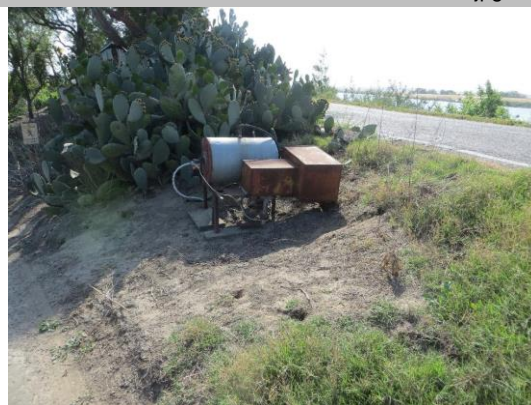
Photo 1 of 2 : UCIP\_SP\_2016\_44726\_73922.jpg

Siphon pump on LS shoulder. No connection at this time.

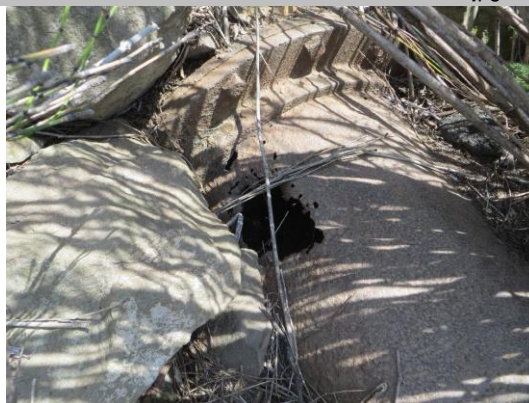
Photo 2 of 2 : UCIP\_SP\_2016\_44753\_73954.jpg

Hole in pipe at WS toe.

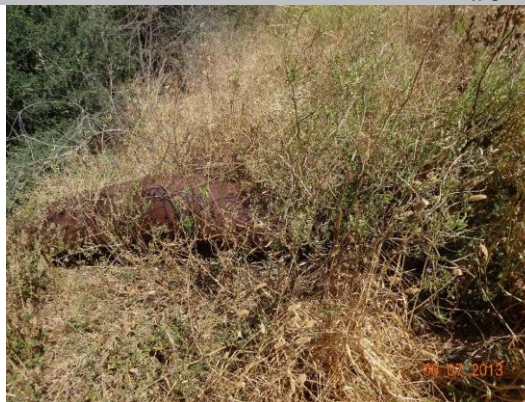
Photo 2 of 2 : UCIP\_SP\_2016\_19657\_33400.jpg

Dense vegetation along the upper portion of the waterward slope prevents proper inspection of crossing.

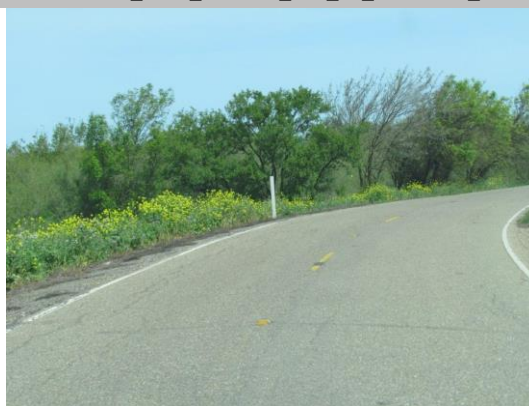
Photo 1 of 1 : SP\_2016\_RD0501\_171\_32\_20160504\_00066.jpg

Looking downstream from levee mile 0.00 to 2.99, tall weeds and wild growth present on the levee slope and shoulder.

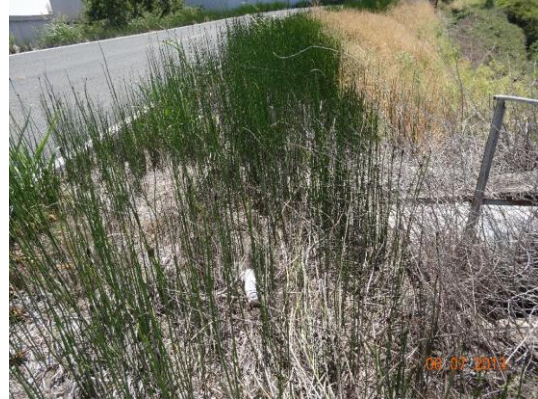
Photo 2 of 2 : UCIP\_SP\_2016\_19662\_33418.jpg

Dense vegetation along the pipe alignment and throughout waterward slope.

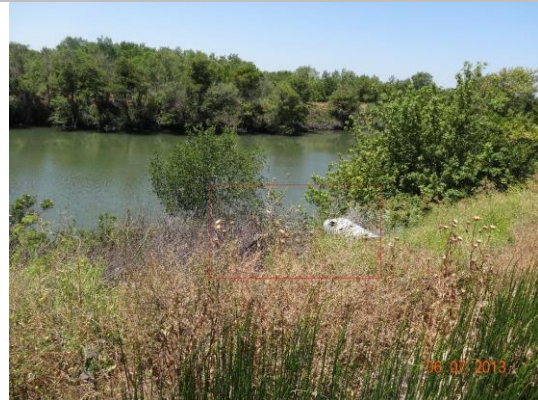
Photo 1 of 2 : UCIP\_SP\_2016\_43524\_33425.jpg

View of waterward side. Dense vegetation limits inspections. Signs of structure visible highlighted by red box.

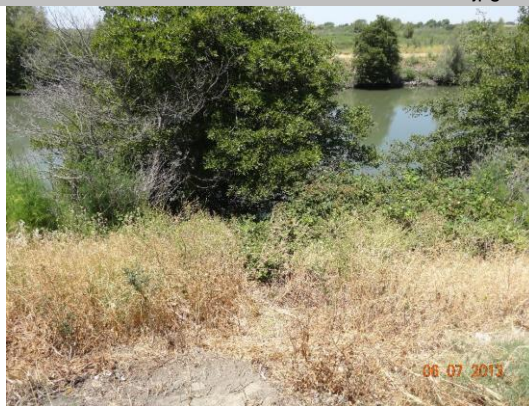
Photo 2 of 2 : UCIP\_SP\_2016\_44876\_33428.jpg

View of waterward slope. Dense vegetation along slope.

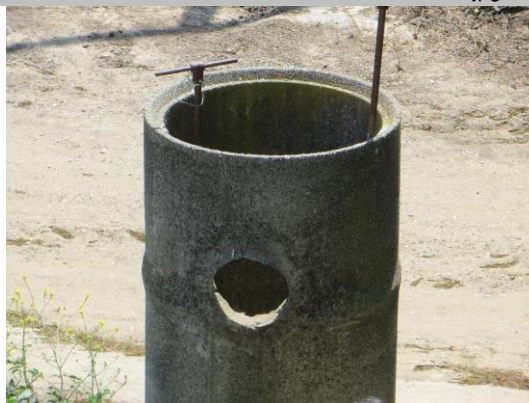
Photo 2 of 2 : UCIP\_SP\_2016\_44746\_73943.jpg

10-inch diameter hole cut in side of standpipe where pipe once was installed.

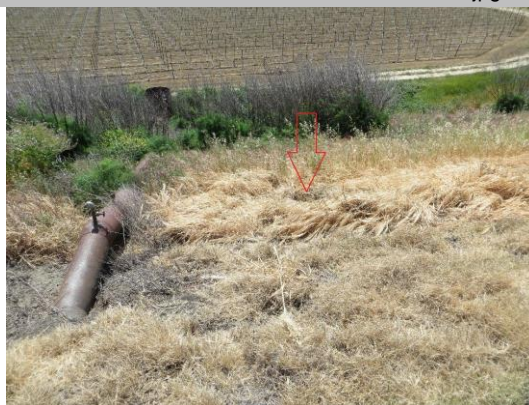
Photo 1 of 2 : UCIP\_SP\_2016\_44877\_73946.jpg

Buried pipe exposed in trench 8-feet downstream from visible pipe.

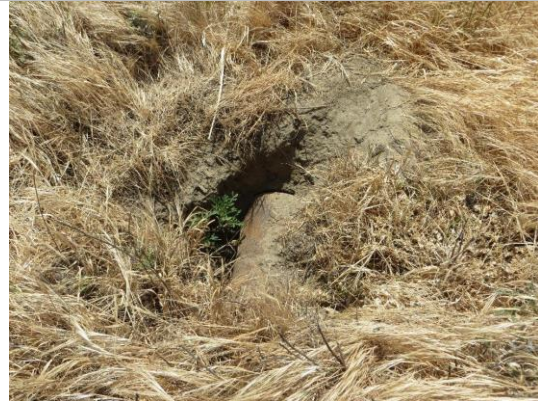
Photo 2 of 2 : UCIP\_SP\_2016\_44877\_73945.jpg

Cut in buried pipe on LS shoulder.

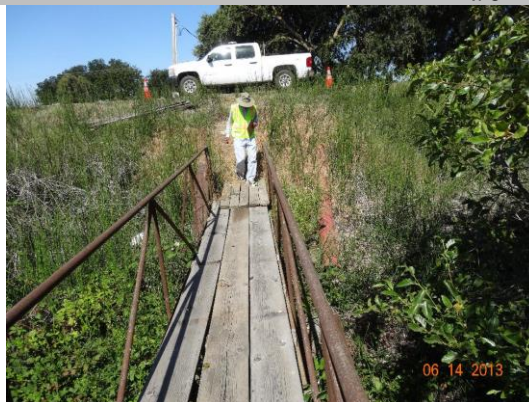
Photo 2 of 2 : UCIP\_SP\_2016\_32551\_59072.jpg

Abandoned pipe to the right of walkway.

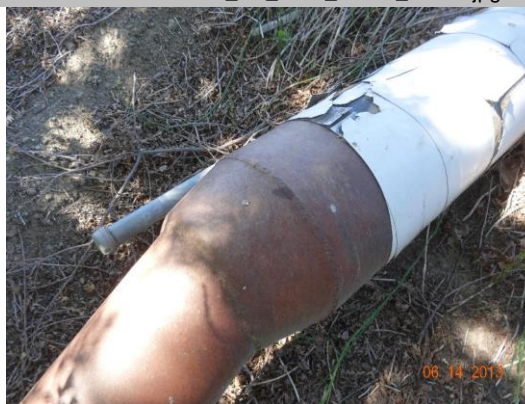
Photo 2 of 2 : UCIP\_SP\_2016\_44471\_33495.jpg

Pipe section reduced at the waterward side daylight.
